Manitoulin-Sudbury District Services Board Ten Year Capital Management Plan

September 2020

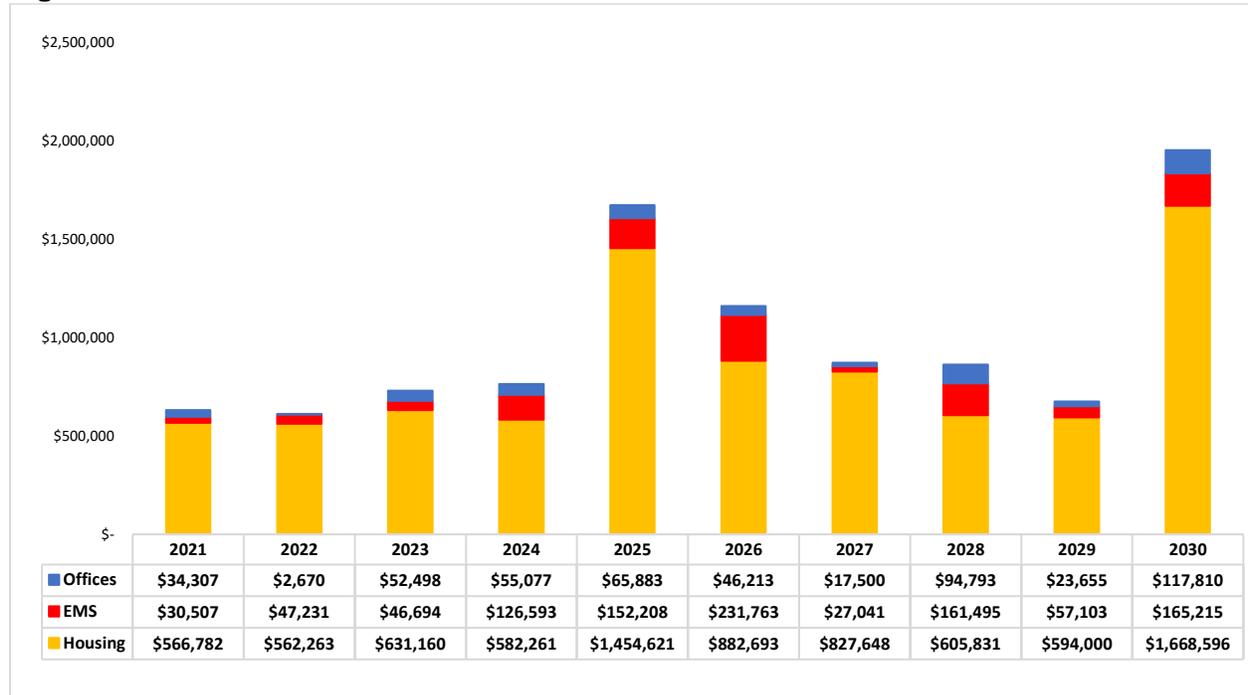
Figure 3: Total Portfolio Costs

It is important to note that these figures represent all of the components of the building, including items that may have past their industry accepted life cycle but, with proper maintenance, will most likely not need replacement. A good example of this would be the hallway railings.

Furthermore, the data shown above does have a discrepancy in Years 2025 and 2030. The reason for the spike shown in costs is due to how the data is captured in the AssetPlanner system. Items generally covered under unit turn-over (painting, flooring, kitchen, and bathroom refurbishment) are summarized in five year increments rather than annually (i.e. Replacement of three unit floors every five years). This is primarily for the ease of maintaining the data by the user. Therefore, the reality of annual costs to the housing portfolio budget will be more evenly distributed than what is shown above.

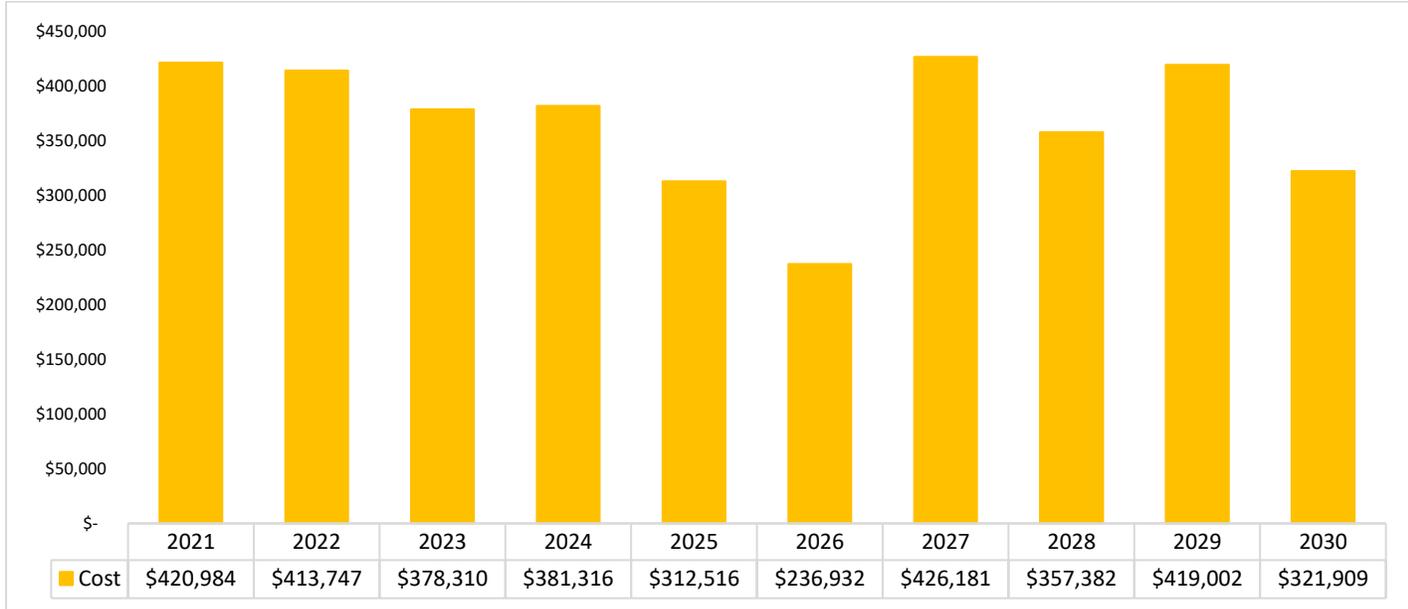
Figure 4: Annual Plan Cost Forecast – Housing

**Costs shown include estimated engineering studies. Does not include project management fees. Approximate project management fees for Year 1 projects can be found in Section 7.1.*

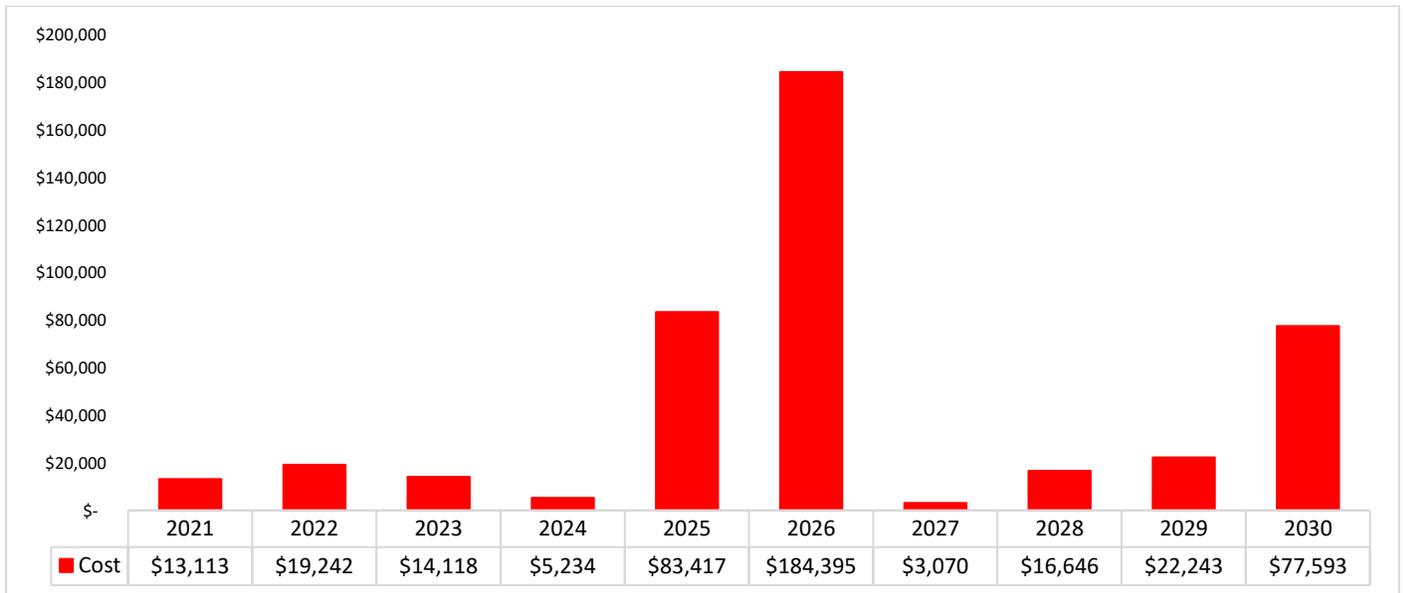
Figure 5: Annual Plan Cost Forecast – Paramedic Services Buildings

**Spike in 2025 and 2026 is due to several cladding (roof & window) projects and possible sanitary replacement at Hagar Paramedic Services*

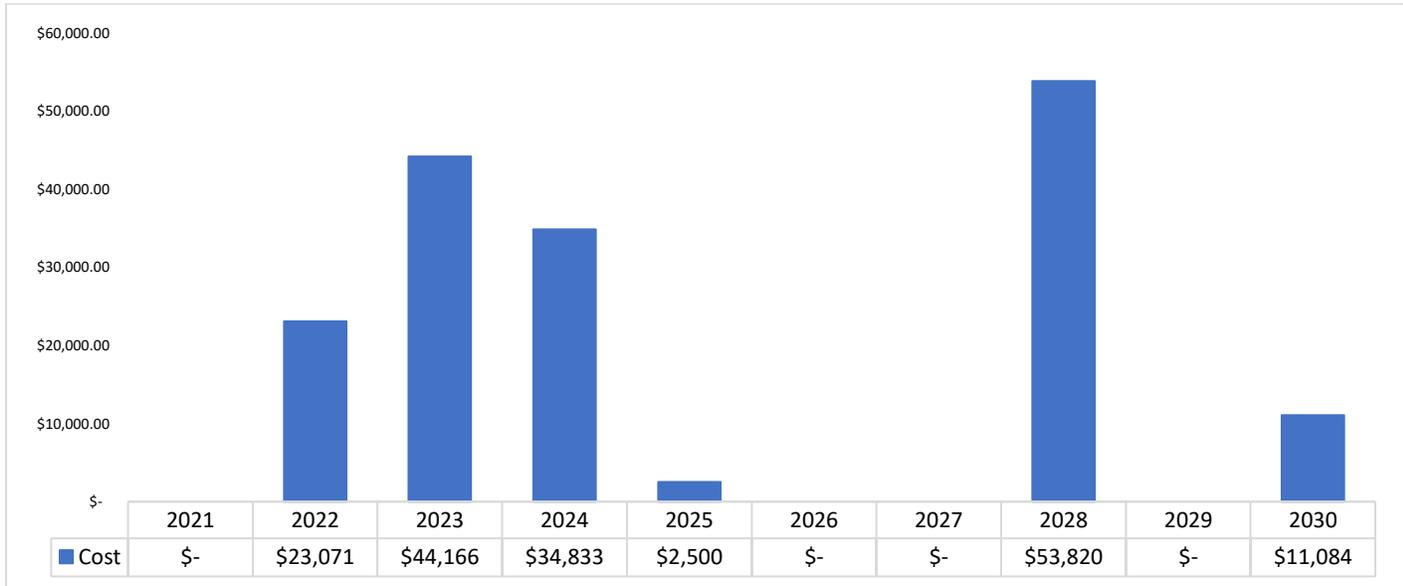
Figure 5: Annual Plan Cost Forecast – Offices Buildings

**Spike in 2023/2024 is due to HVAC replacement at both Mead and Second Ave locations. Spike in 2028 is due to expected Mead Ave. roof replacement*

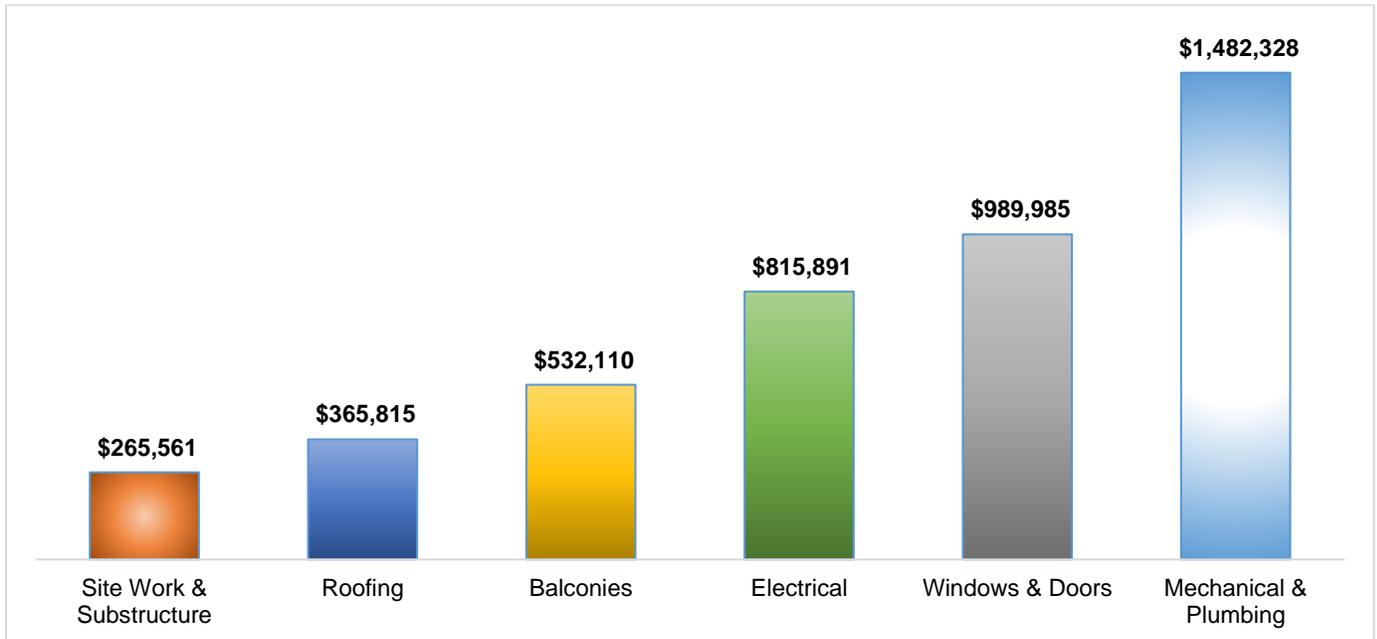
Figure 7: Plan Forecast by Building Components

As the chart above suggests, a high percentage of capital dollars over the next 10 year period should be directed to Mechanical & Plumbing infrastructure, primarily the make-up air units, furnaces, and sprinkler & fire alarm systems.
